Case Study – Industrial Gearbox

Date: February, 2014	Market: Industrial Chemical Refining & Processing
Product: Oil Debris Sensor - Model Number 1599-00-035		
Description of existing application	24 hour operation of a gear reduced drum power unit. The existing system included a network of vibration sensors.	
Gear RPM Range: 1,500 to 8

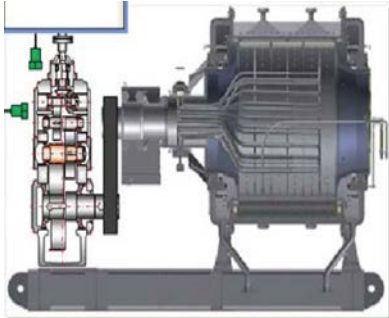
<p>21kW electric motor driving gear box</p>

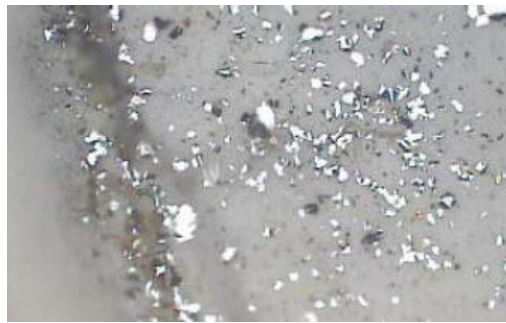
3. Inspection : a large amount of ferrous particles were detected by used oil analysis (on 2/5 2013 at 16:00) as a result of gear abrasion. And gear flaking and three cracks were found on gear no.4.

Actual debris removed from oil reservoir after voltage increase.

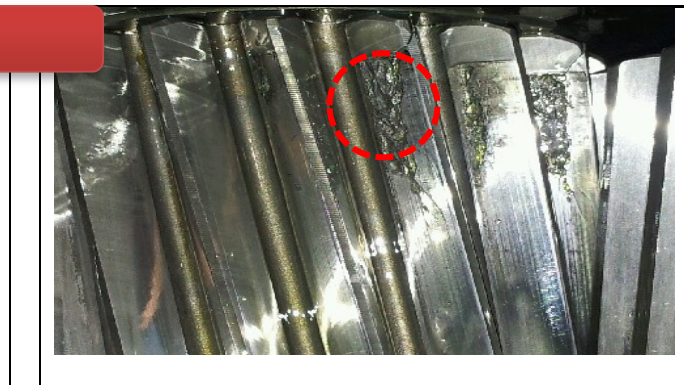
Gear No. 4 (green, small)

Actual Gear damage as viewed at inspection May 1, 2013

System responsiveness was effective at immediately taking action (inspection) after observing the voltage increase from 0.6 to 1.3 volts. Preventative action taken was swapping in a new gear reduction unit and avoiding expensive downtime.
