## Case Study

*Ref: FP23*

*2012 London Olympic Park;*

*June/July 2012*

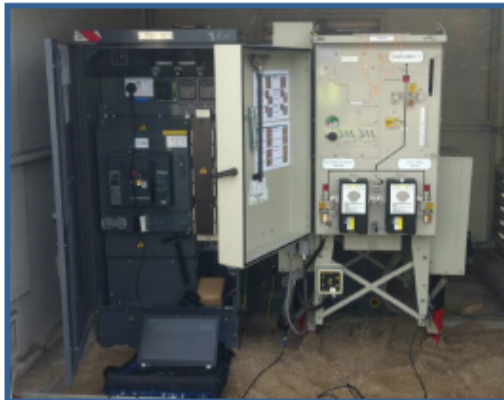
*PrecisePD being used to test the RMU*

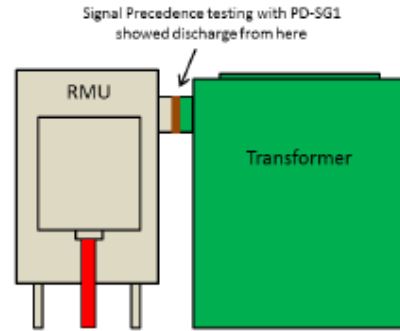
Signal precedence testing was used to establish where on the switch the PD was coming from and it was found that the discharges were emanating from the horizontal coupling between the RMU itself and the transformer.

Typical PD pattern seen on the discharging RMUs

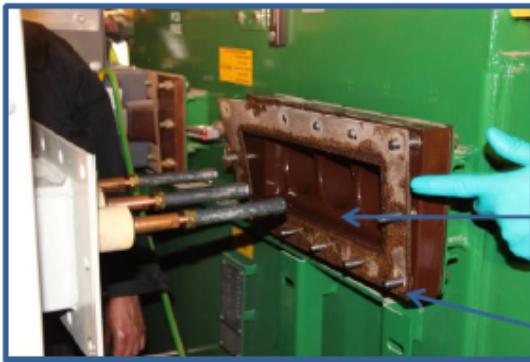
When the opportunity arose, maintenance was carried out. It was found that the bottom of the gasket between the RMU and transformer was discoloured with oil and when the two were separated, oil ran freely out of the monoblock, a part that should not have contained oil.

RMU and Transformer separated showing the epoxy monoblock that is seated inside the transformer

Gasket discoloured by oil

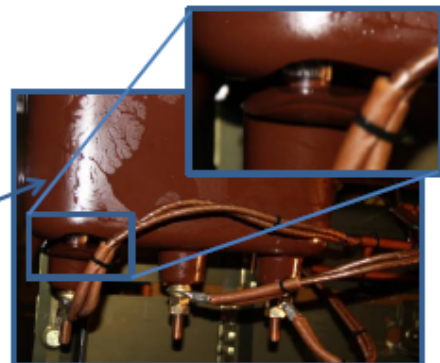
It was found once the RMU and Transformer were separated that the epoxy monoblock had broken during installation. The male connectors on one of the phases had been set too long and when the two were bolted together the base of the monoblock had sheared off completely allowing oil from the transformer to leak into the coupling component.

Broken monoblock

When an opportunity arose to carry out a full investigation, the cause was found to be faulty equipment installation.
