Case Study: Fault Prevented in Switchgear, UK utility customer

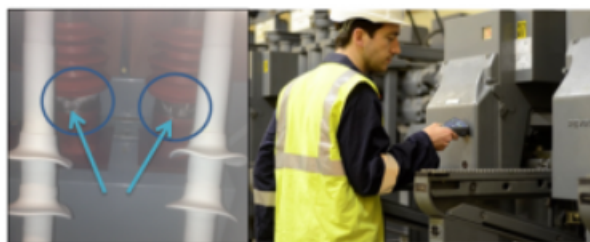
Partial Discharge spot testing was carried out in the 33kV substation. High TEV signals were detected across the switchboard. A PD source was identified originating from the bus bar enclosure of this panel. A switching investigation was conducted and the panel was de-energized cable box, opened and visually inspected. Upon inspection evidence of surface tracking damage from electrical stress was seen around the through brushing. The result is a breakdown in the polymer and a chemical compound 'nitrate oxide' which is the white residue seen on the brushings in this picture. This corresponded to IPECs initial spot testing results. It was concluded that the through brushings should be changed. IPEC received confirmation that the through brushings have been changed and that all discharge activity has completely stopped.

IPEC identified and located a source of partial discharge at the 33kVB substation. A combination of; spot testing, HFCT procedure testing, CC(TEV) procedure testing and airborne acoustic testing was used to located the PD source. The company went on to replace the through brushings and a switchgear fault has been prevented.
