Case Study

Partial Discharge monitoring of HV cable

110kV Cable, Ningxia Xinxì, China;

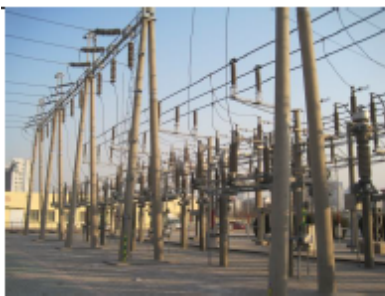
The cable circuit is routed between an outdoor AIS substation at Xincheng and an indoor GIS substation at Xihu in the centre of Ningxi, China.

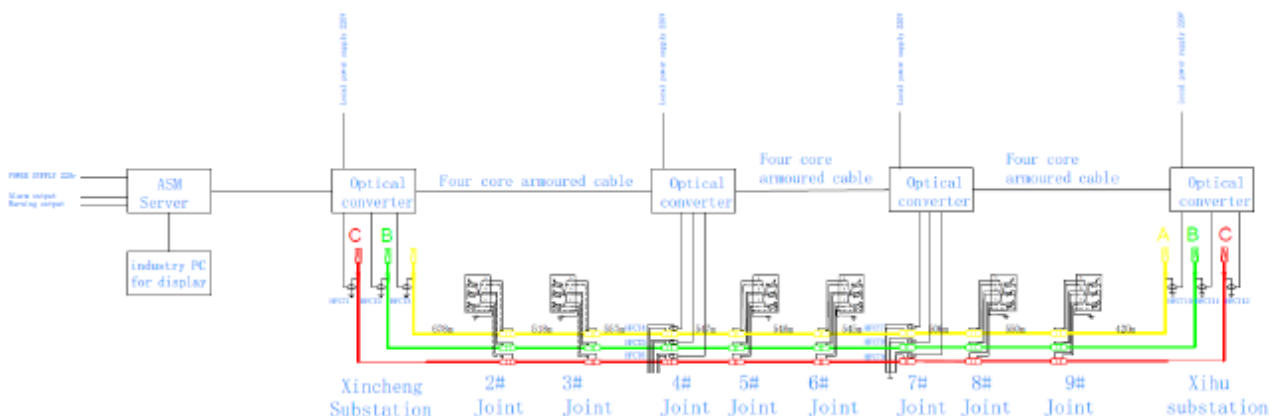
The 5km circuit has 9 cable sections with 8 joints, 6 of which are cross bonded. Monitoring points were installed in the cable tunnel at the cable terminations and at joints No 4 and No 7 as indicated in the diagram below. This means that no joint on the circuit is more than 1 cable section away from a pointing point.

Each monitoring point has three HFCT PD sensors, one connected to the earth strap of each phase. The monitoring points were interconnected by a fibre optic running the complete length of the circuit.

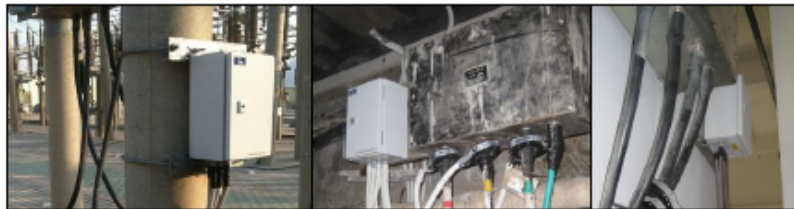
At each monitoring point a Data Acquisition (DAQ) Unit was installed with 3 high frequency current transformer (HFCT) transducers. These are specially designed PD sensors that pick up very small HF current pulses induced in the cable earthing system in the event of a partial discharge.

DAQ at Xincheng Substation

DAQ at Joint No 4

DAQ at Xihu Substation

Some parts of the tunnel are prone to flooding and water levels could come higher than the mounting position of the DAQ Units on the tunnel wall. In addition, the DAQ Unit at Xincheng substation is mounted outdoors and exposed to rain. The DAQ Unit enclosures were therefore rated to IP67.

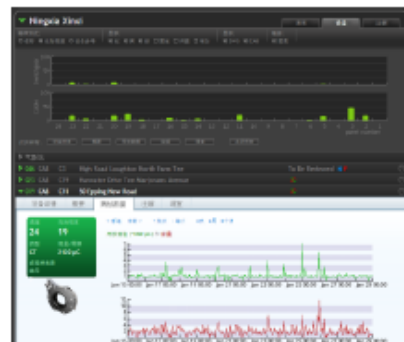
Monitor

The monitor installed at Xincheng Substation is rack mounted with managed UPS and a local data server. Data acquired by the monitor is stored locally on the server and made available via powerful web based analysis tools that allow the user to observe trends in activity and get an overall view of the current and historical criticality of all the monitored assets. In the event that any PD is detected, detailed analysis can be carried using the web tools that show Phase Resolved PD (PRPD) patterns and pulse wave shapes. This enables PD sources to be accurately located along the circuit length.
