APPLICATION SOLUTION

Industry: Aircraft

Customer: Major Helicopter Manufacturer

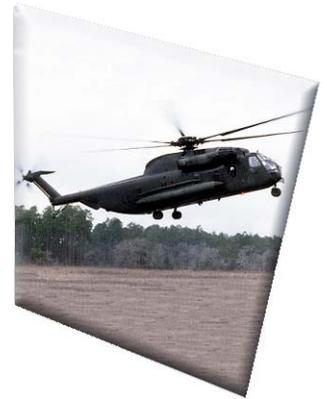
Challenge: Monitor critical grease-lubricated powertrain bearing dependably while surviving the tough helicopter environment. Accelerometers are located on the rotor swashplate assembly and the bearing housings of the tail rotor drive train. The swashplate sensors are exposed to the airstream as the helicopter is in flight while the drive train accelerometers are exposed to temperature, grease and hydraulic fluid.

The Wilcoxon 908TS-1 and 908TS-2 vibration sensors, which feature integral cables, were designed and built specifically for this helicopter manufacturer to meet their specs. Since Wilcoxon Research builds most of their sensors for harsh industrial applications, they were readily able to meet the rugged design requirements. Another vendor was originally used for their sensors, but the sensors were not Electromagnetic Interference (EMI) protected. This caused radio frequency signals to produce false vibration readings. Because the Wilcoxon 908TS-1 and 908TS-2 are EMI protected, this problem has been eliminated.
