## APPLICATION SOLUTION

**Industry:** Printing & Publishing

**Customer:** Major East Coast Newspaper Publisher

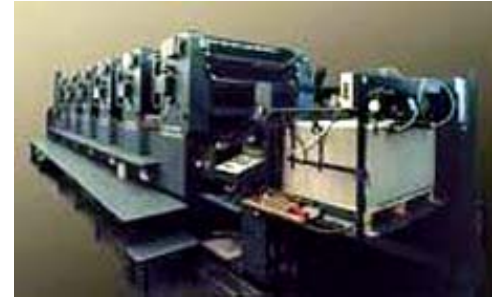
**Challenge:** The folding machine is fed from ten separate press lines. It can fold up to 1,000 sections per

minute. The folding arm swings on each folding operation and is mounted on a planetary gearbox. When that gearbox bearing fails it often seizes and shuts down the folding operation. It has cost up to \$150,000 for repairs after one of these failures. A scheduled re-build of a folding machine costs \$15,000.

The vibration analyst for this leading newspaper says, "The planetary gearbox and bearing are the heart of the folding machine, so monitoring that area would be ideal, but it moves too fast. Installing the 797T-1 and the 793 accelerometers on the center spine bearing housing gets us close enough."
