Case Study – Industrial Gearbox

Date: February, 2014	Market: Industrial Chemical Refining & Processing
Product: Oil Debris Sensor - Model Number 1599-00-035		
Description of existing application	24 hour operation of a gear reduced drum power unit. The existing system included a network of vibration sensors.	
Gear RPM Range: 1,500 to 8

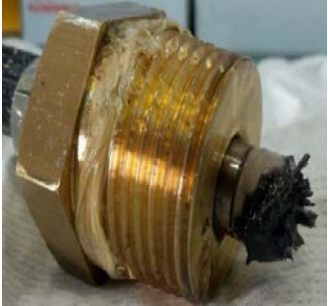
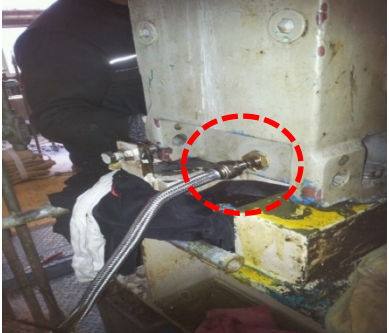
Description of new sensor in application	Placed the 1599 two channel sensor into the bottom of the oil tank via a retrofitted brass drain plug with exposed sensor assembly in its center. (Photo taken after second inspection) Remote electronics placed in a protected electronics enclosure away from gearbox.

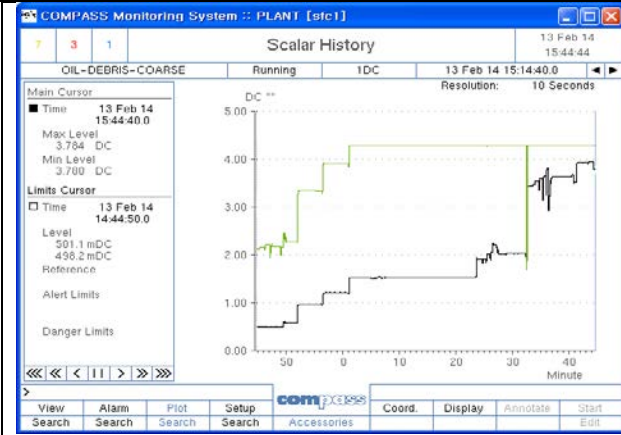
1. 1599 wear debris sensor was installed on Feb 25 2013

2. Detection : On May 1, 2013 at 16:47 Debris Sensor (Large Particle) Voltage rate of the sensor increased 0.6V to > 1.6V.

3. Inspection : a large amount of ferrous particles were detected by used oil analysis (on 2/5 2013 at 16:00) as a result of gear abrasion. And gear flaking and three cracks were found on gear no.4.

System responsiveness was effective at immediately taking action (inspection) after observing the voltage increase from 0.6 to 1.3 volts. Preventative action taken was swapping in a new gear reduction unit and avoiding expensive downtime.

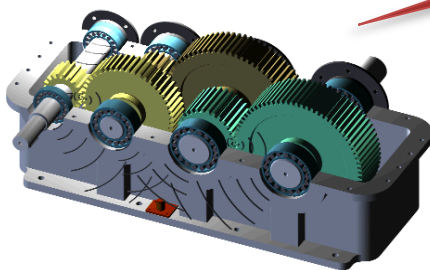
Gear No. 4 (green, small)

Actual Gear damage as viewed at inspection May 1, 2013
